Case Study: Conveyor Belt in Multinational Retailer's Fulfillment Center

Tray router discharge identified by MSAI Connect

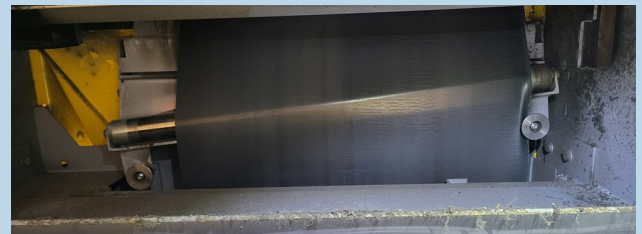
MSAI Connect detected a steady rise in heat on the tray discharge belt creating a critical maintenance alert. Upon inspection, the belt had tracked to the left, over the knife roller and was rubbing up against the side guarding and over the tracking unit on the underside of the belt. As this belt is fed from the Tray router Main Motor it would have ripped the belt off as no overload would have been detected as per the design.

The tracking roller failure led to the belt veering off the tracking unit, resulting in an elevated temperature

An inspection window was agreed upon, resulting a short period of downtime, as the belt's failure was imminent. The reliability team was able to diagnose and correct the root cause of the belt misalignment, allowing operations to resume less than an hour after the MSAI Connect alert.

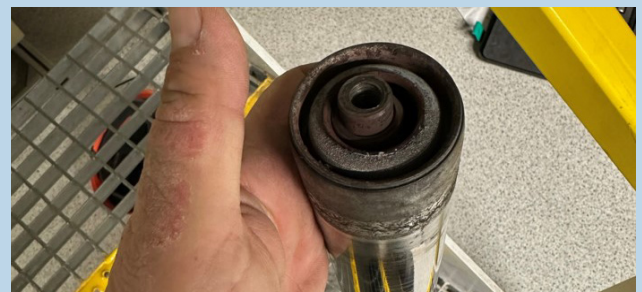
Failed Bearing on Tracking roller
