Case Study: Conveyor Belt Failure in Multinational Retailer's Fulfillment Center

Friction-caused belt wear identified by MSAI Connect

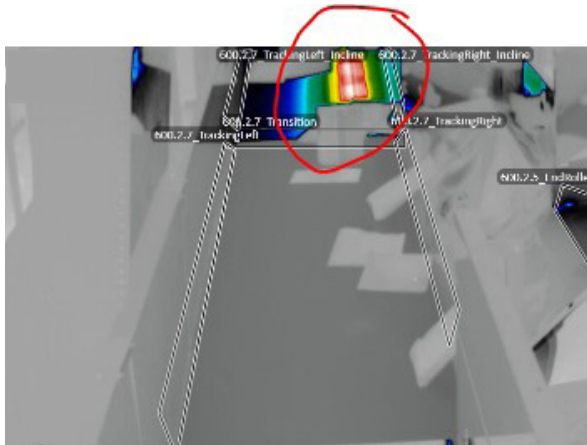
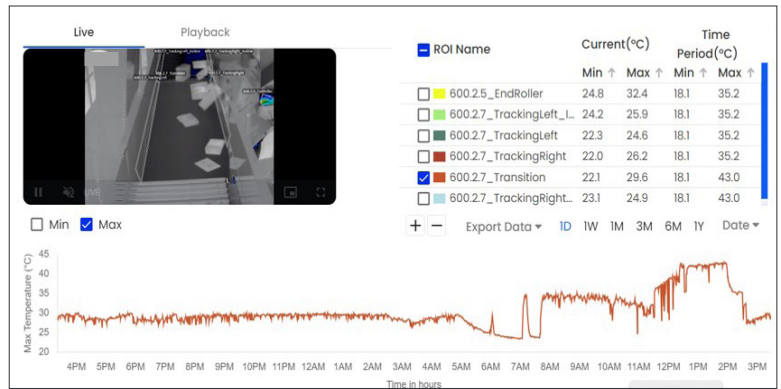
MSAI Connect identified a hotspot on a conveyor belt. Visual investigation found two packages jammed in the guard, rubbing against the belt and causing the raise in temperature on the exit side of the conveyor.

Lock out, tag out was applied and packages were removed and returned to problem solve. Visual inspections of the belt were performed to check for damage. MSAI Connect continuously monitored the belt for any tracking issues and signs of belt damage thereafter.
