Case Study: Conveyor Belt in Multinational Retailer's Fulfillment Center

Tray router discharge identified by MSAI Connect

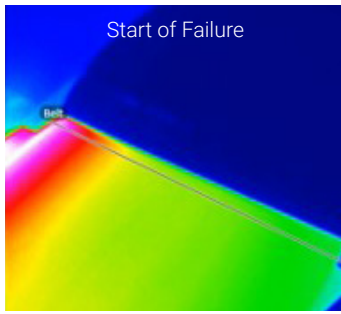
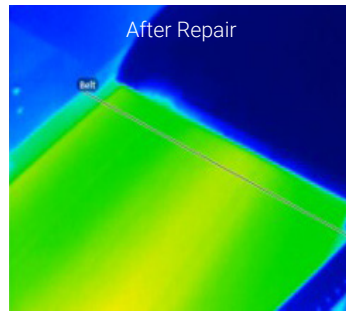
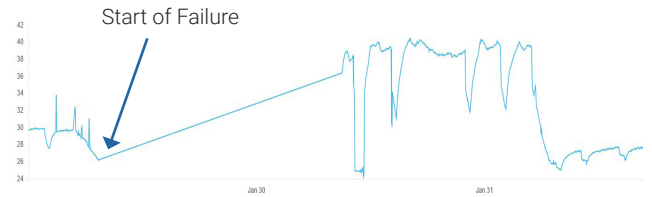
MSAI Connect detected a steady rise in heat on the tray discharge belt creating a critical maintenance alert. Upon inspection, the belt had tracked to the left, over the knife roller and was rubbing up against the side guarding and over the tracking unit on the underside of the belt. As this belt is fed from the Tray router Main Motor it would have ripped the belt off as no overload would have been detected as per the design.

An inspection window was agreed upon, resulting a short period of downtime, as the belt's failure was imminent. The reliability team was able to diagnose and correct the root cause of the belt misalignment, allowing operations to resume less than an hour after the MSAI Connect alert.
